# Weekly Construction Report

## Hatchery Creek Design/Build Project

| <b>Time Period:</b> | November 10-15, 2014 | <b>Project No:</b> | 1305 |

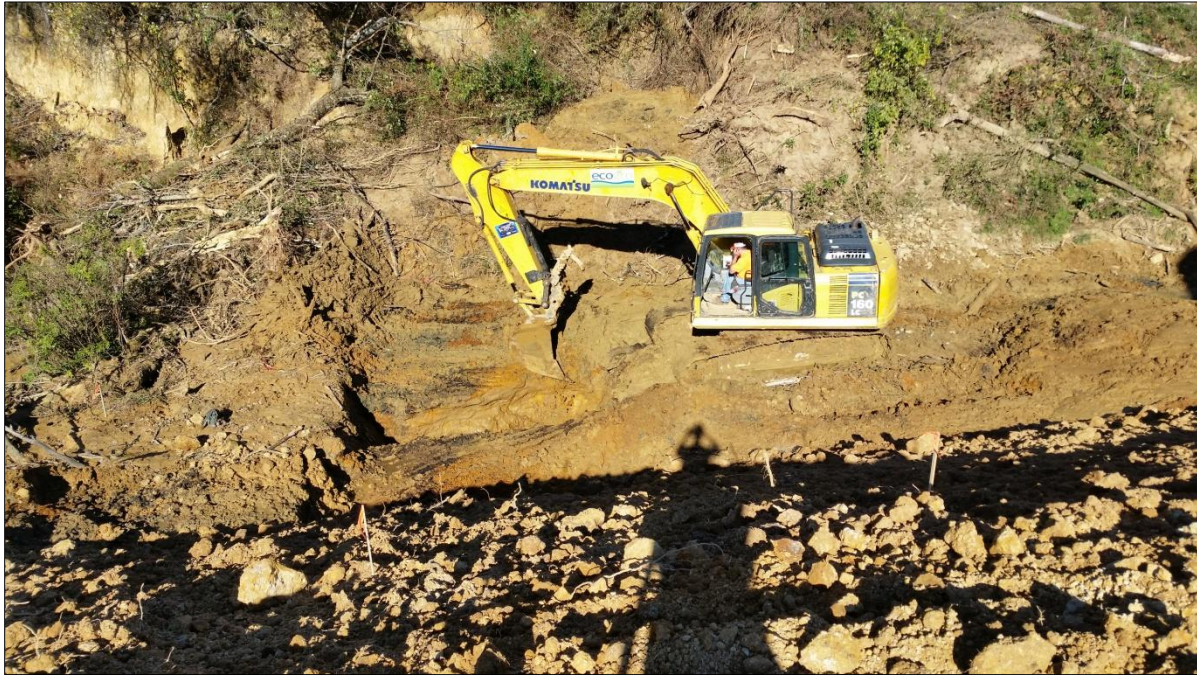
***Excavating for plunge pool at end of rock spillway at Sta. 106+00, ~180 LT (Photograph taken from LT bank of ravine).***

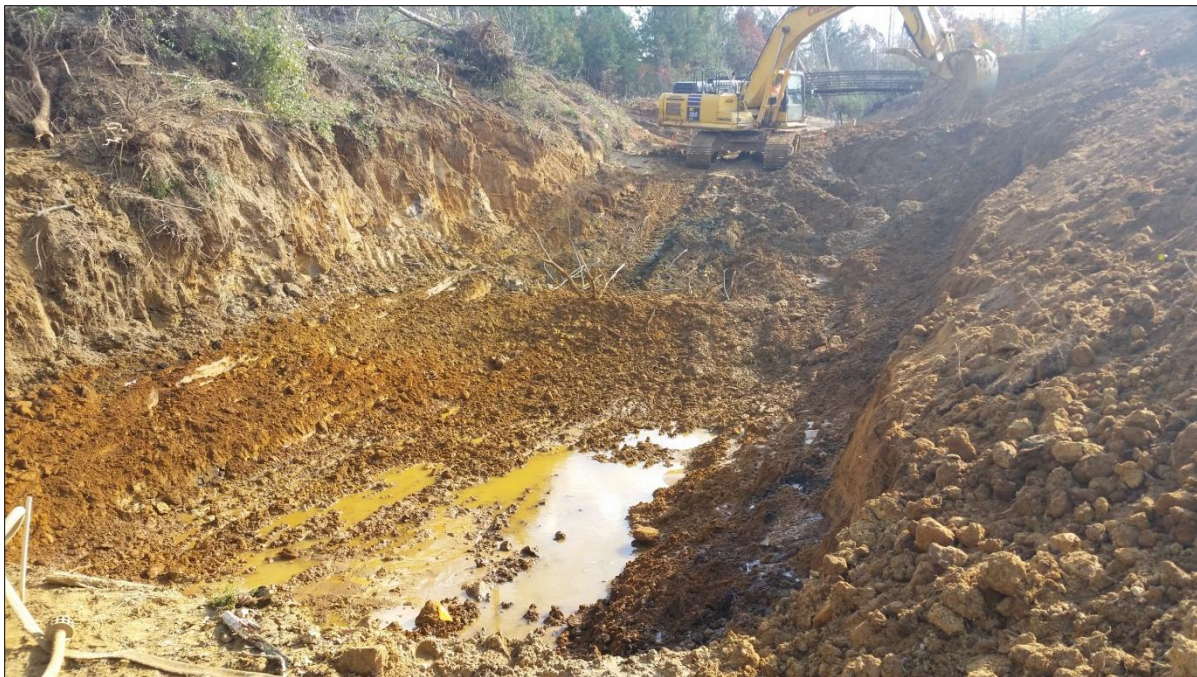
***Plunge pool excavated at end of rock spillway in ravine (Photograph taken from ~Sta. 106+00, ~180 LT, looking upstream).***

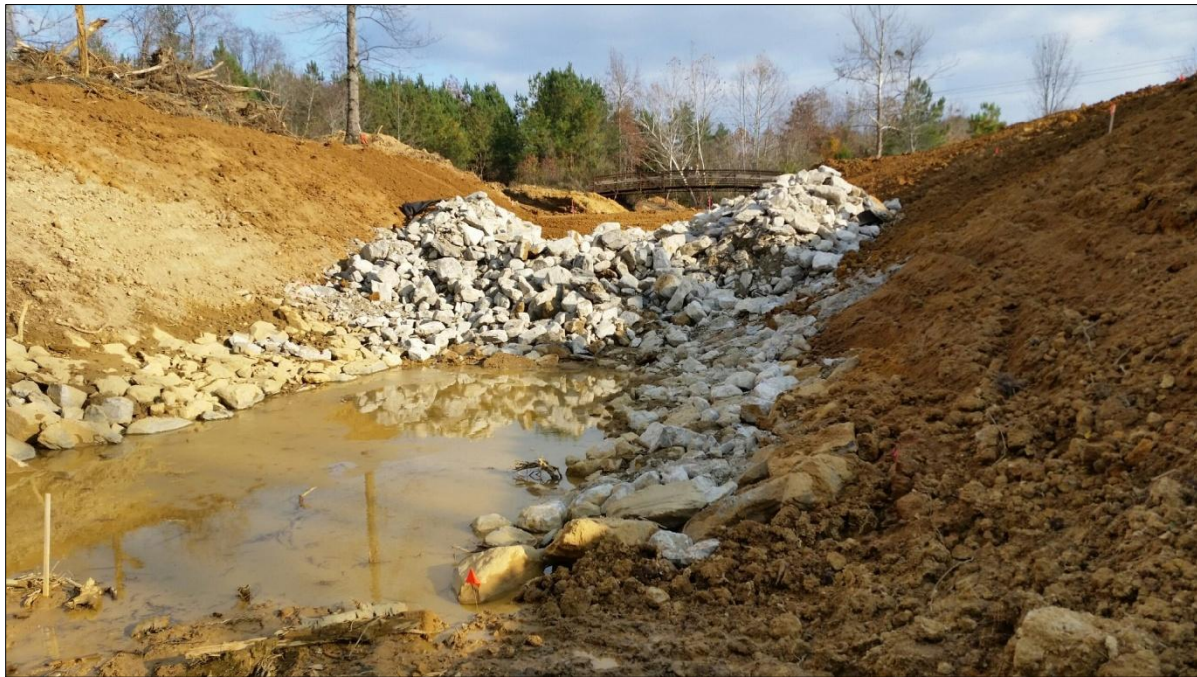
***Ravine sides were sloped and plunge pool was built at end of rock spillway in ravine. Rock spillway was built up to ~elevation 575'. Extra rock was temporarily stockpiled at top of constructed section. (Photograph taken at approximate same location as previous photograph).***

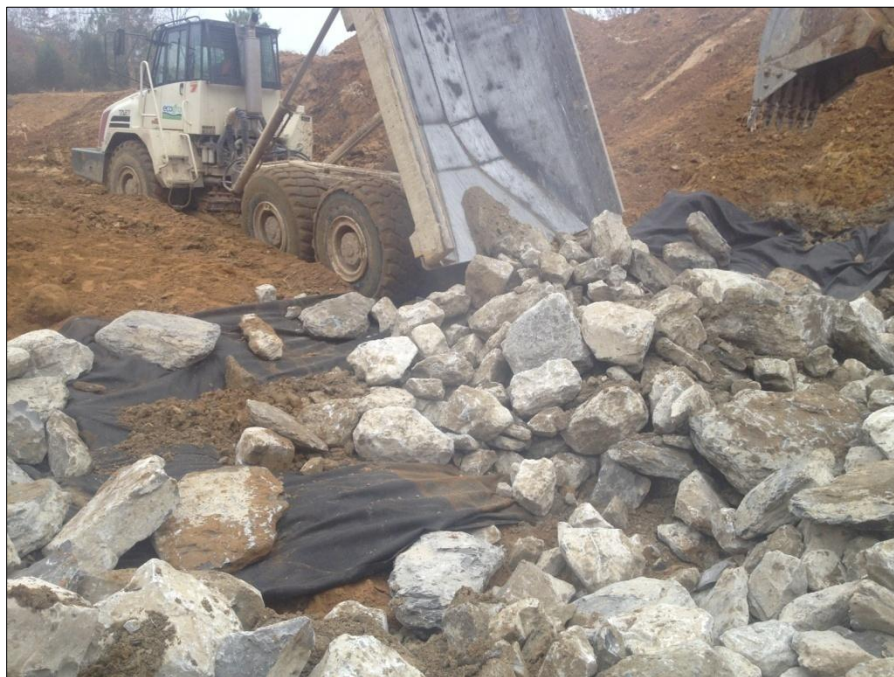
***Delivering rock to spillway in ravine.***

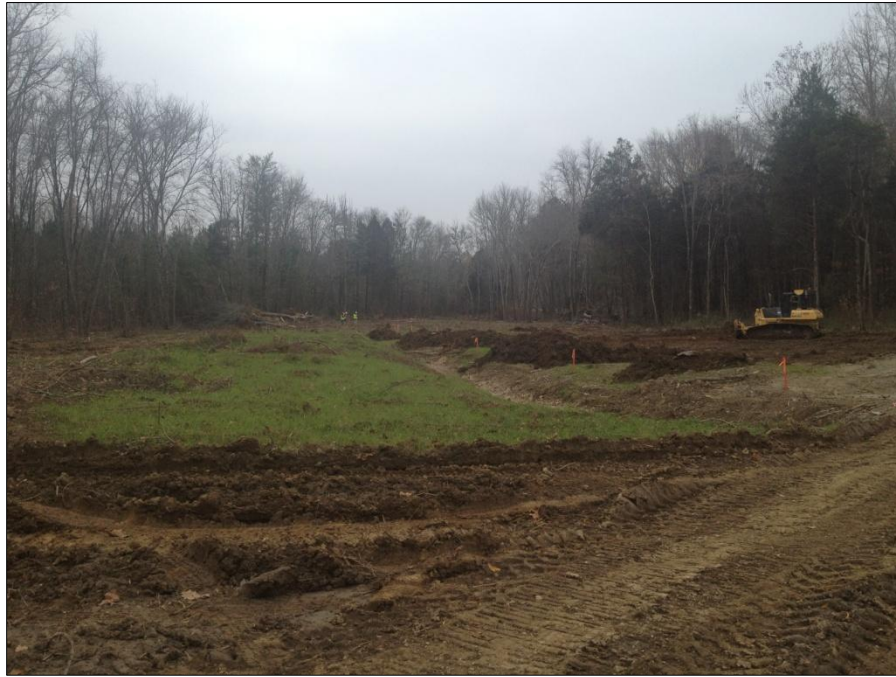
***Aspen Construction started excavating topsoil from Site #3. (Photograph was taken from existing gravel road at ~Sta. 157+50 looking upstream).***
